**DRAFT FINAL
INTERIM REMEDIAL MEASURES
WORK PLAN
EKCO HOUSEWARES FACILITY
MASSILLON, OHIO**

December 1993

ROY F. WESTON, INC.
1 Weston Way
West Chester, Pennsylvania 19380

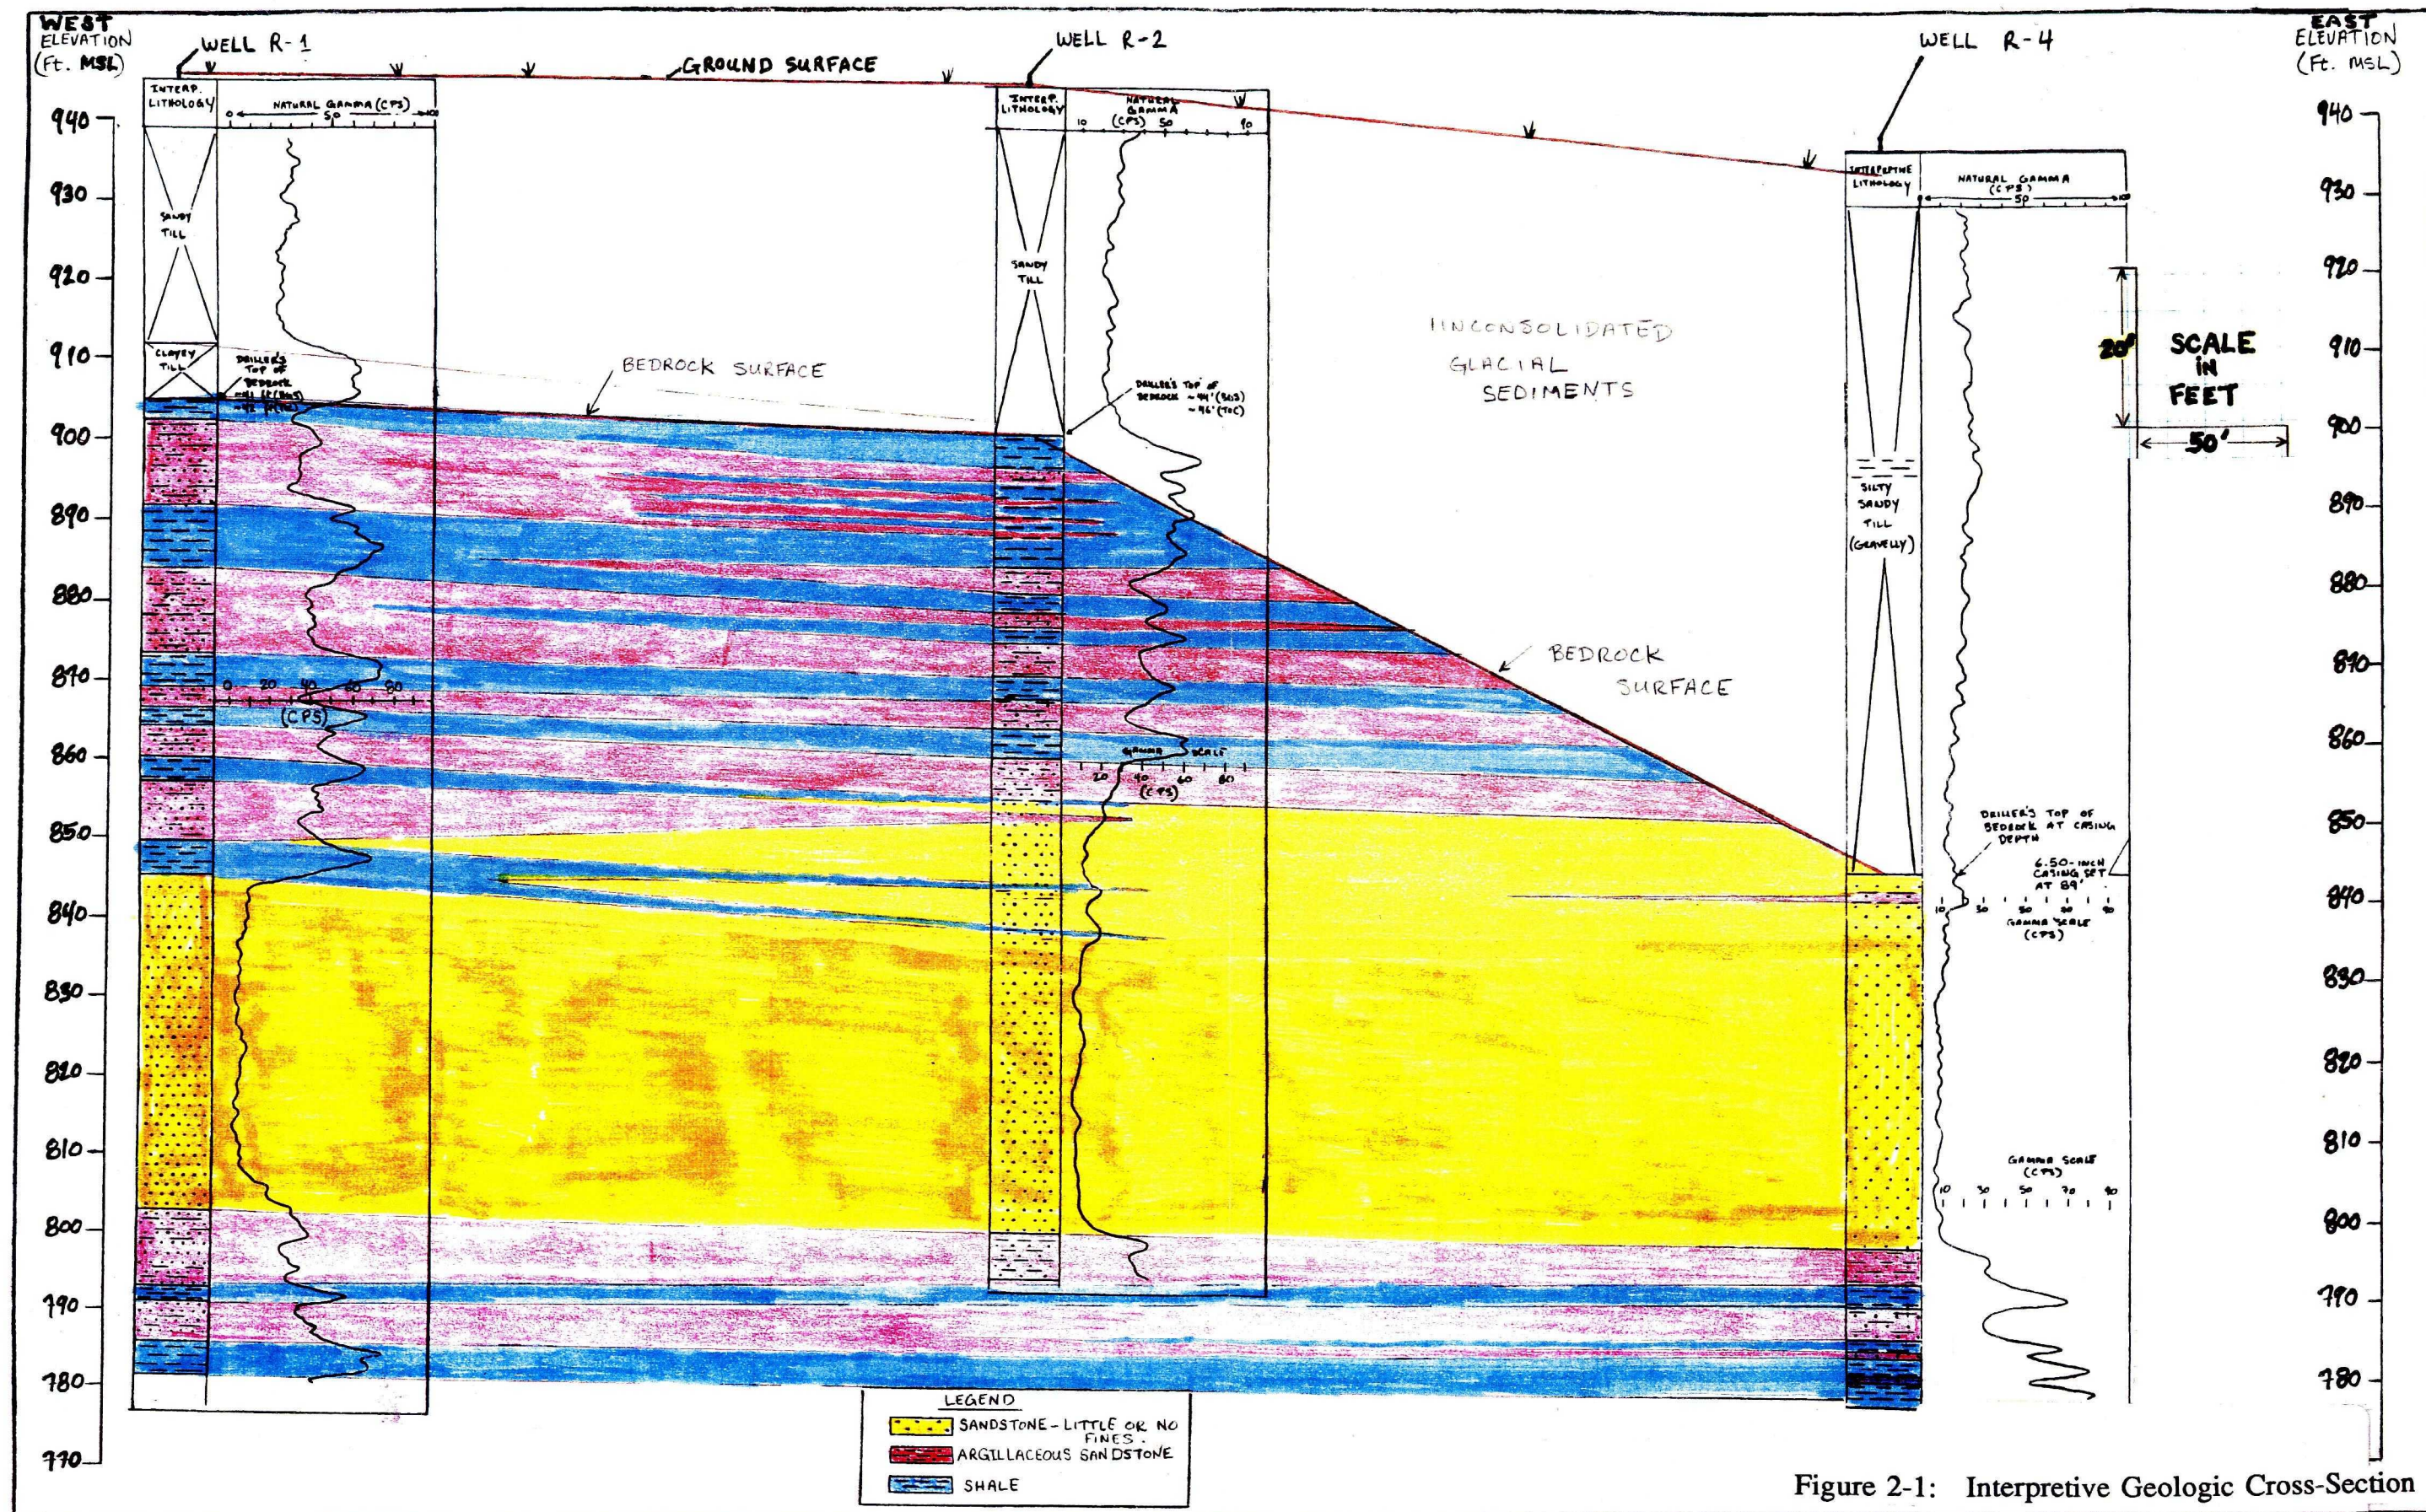
Figure 2-1: Interpretive Geologic Cross-Section

Figure 2 shows an interpretive geologic cross-section of the stratigraphic units penetrated by wells R-1, R-2 and R-4. The cross-section is based primarily on the results of the geophysical logs, driller's logs and regional data from the U.S. Geological Survey (USGS). Copies of the geophysical logs from wells R-1, R-2 and R-4 are provided in Appendix A.

The productive sandstone unit which exists in the three wells is indicated on the logs by low gamma response (approximately 10 counts per second [cps]) and correspondingly high electrical resistance. The low gamma activity implies a low percentage of fine-grained materials in the matrix of this sandstone member, which accounts for its relatively permeable nature. The overlying argillaceous sandstones in wells R-1 and R-2, indicated on the logs by relatively moderate gamma response (30-50 cps), implies the presence of interstitial clay or silts which reduce the permeability of water-bearing geologic deposits.

The shale beds in wells R-1 and R-2 are indicated on the logs by relatively high gamma response (50-70 cps) and correspondingly low electrical resistance. Shales are by definition low in permeability unless secondary fracturing has occurred. The sedimentary rocks in the region of the site have not undergone any appreciable deformation and, in fact, dip only slightly to the southeast (USGS).

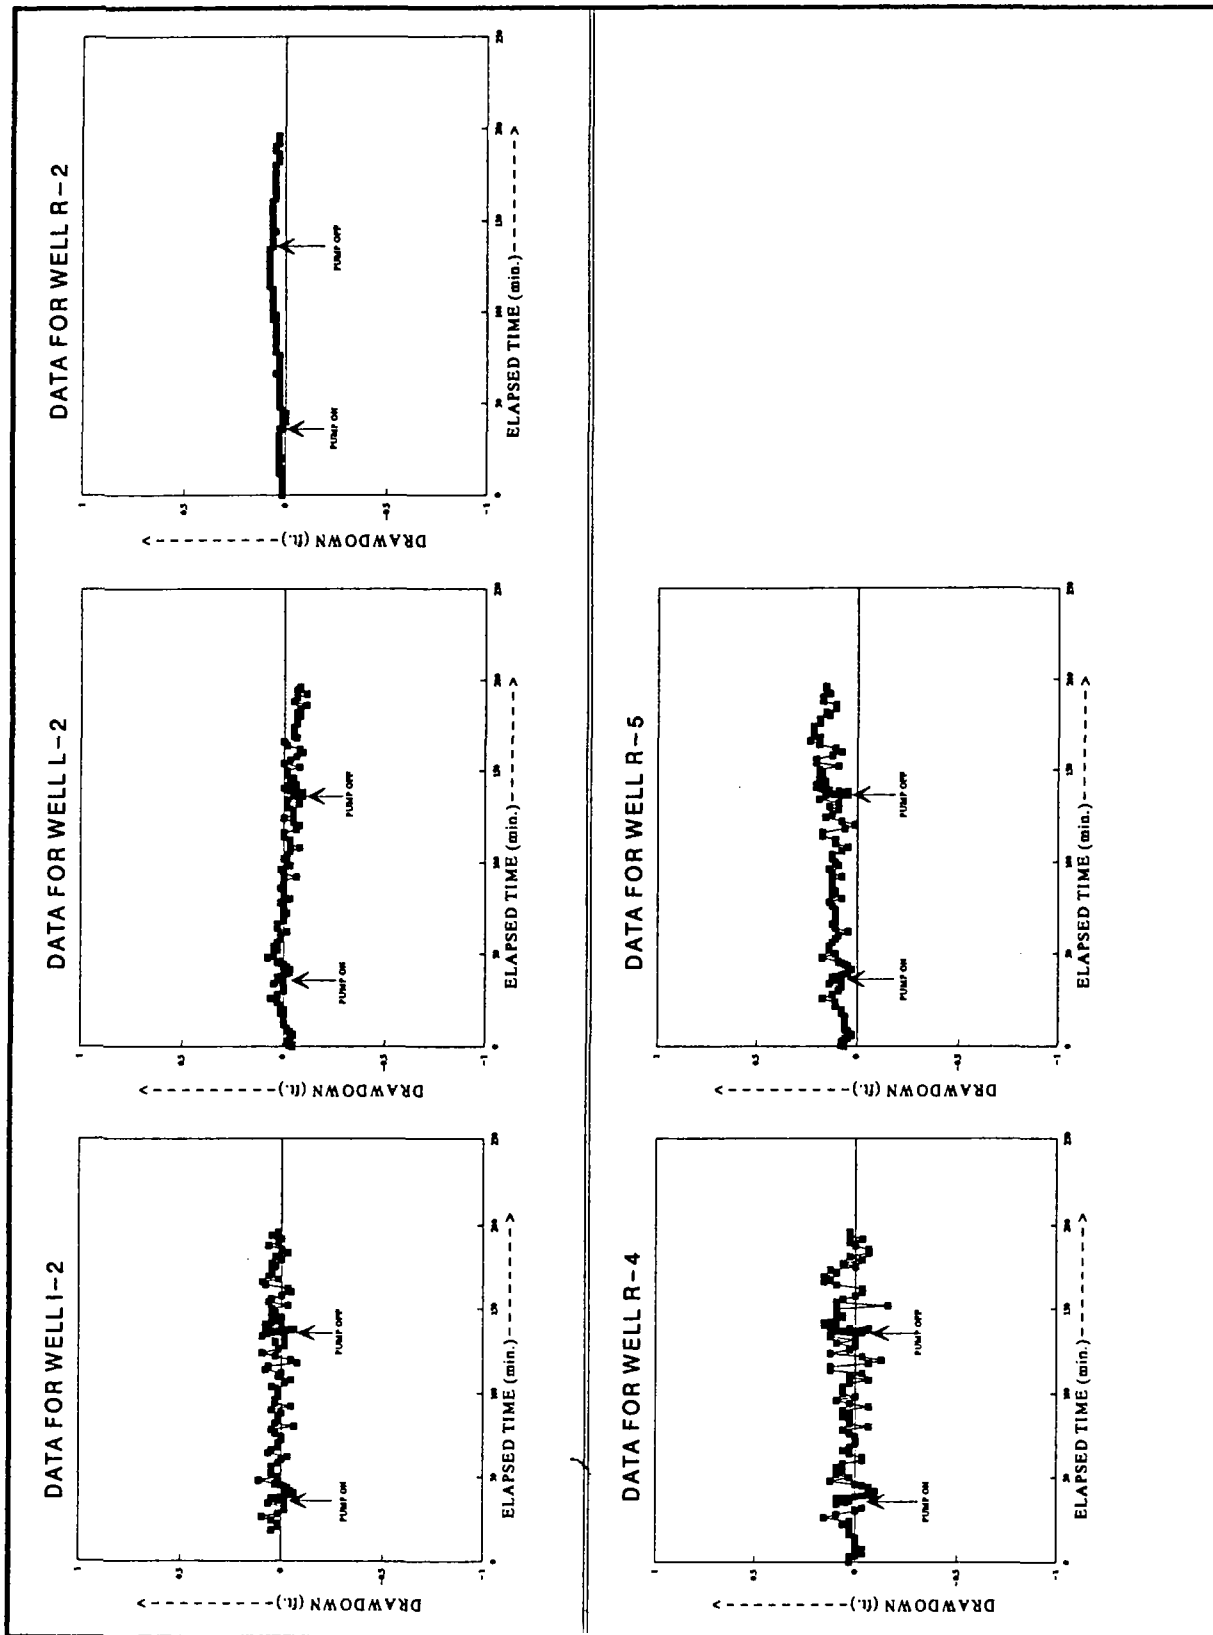
Figure 3-3: Water Level Drawdown Curves for the Observation Wells for Test R-1, Zone-1

The time-drawdown graph for Well R-1 during the Zone 1 packer test is shown in Figure 3-2. The flow rate was stepped up four times to a maximum rate of 24 gpm. The water level below the upper packer in Zone 1 was lowered 13.2 feet during the drawdown and fully recovered when the pump was shut off. The water level above the packer did not change during the test indicating that the packer seal was not leaking and that the overlying shale acted as a barrier to groundwater flow during the test. Figure 3-3 shows the time-drawdown graphs for the five observation wells monitored during the Zone 1 test. The time when the pump in Well R-1 was turned on and off is indicated on each graph. As can be seen in Figure 3-3, no significant drawdown occurred in any of the observation wells during the test.

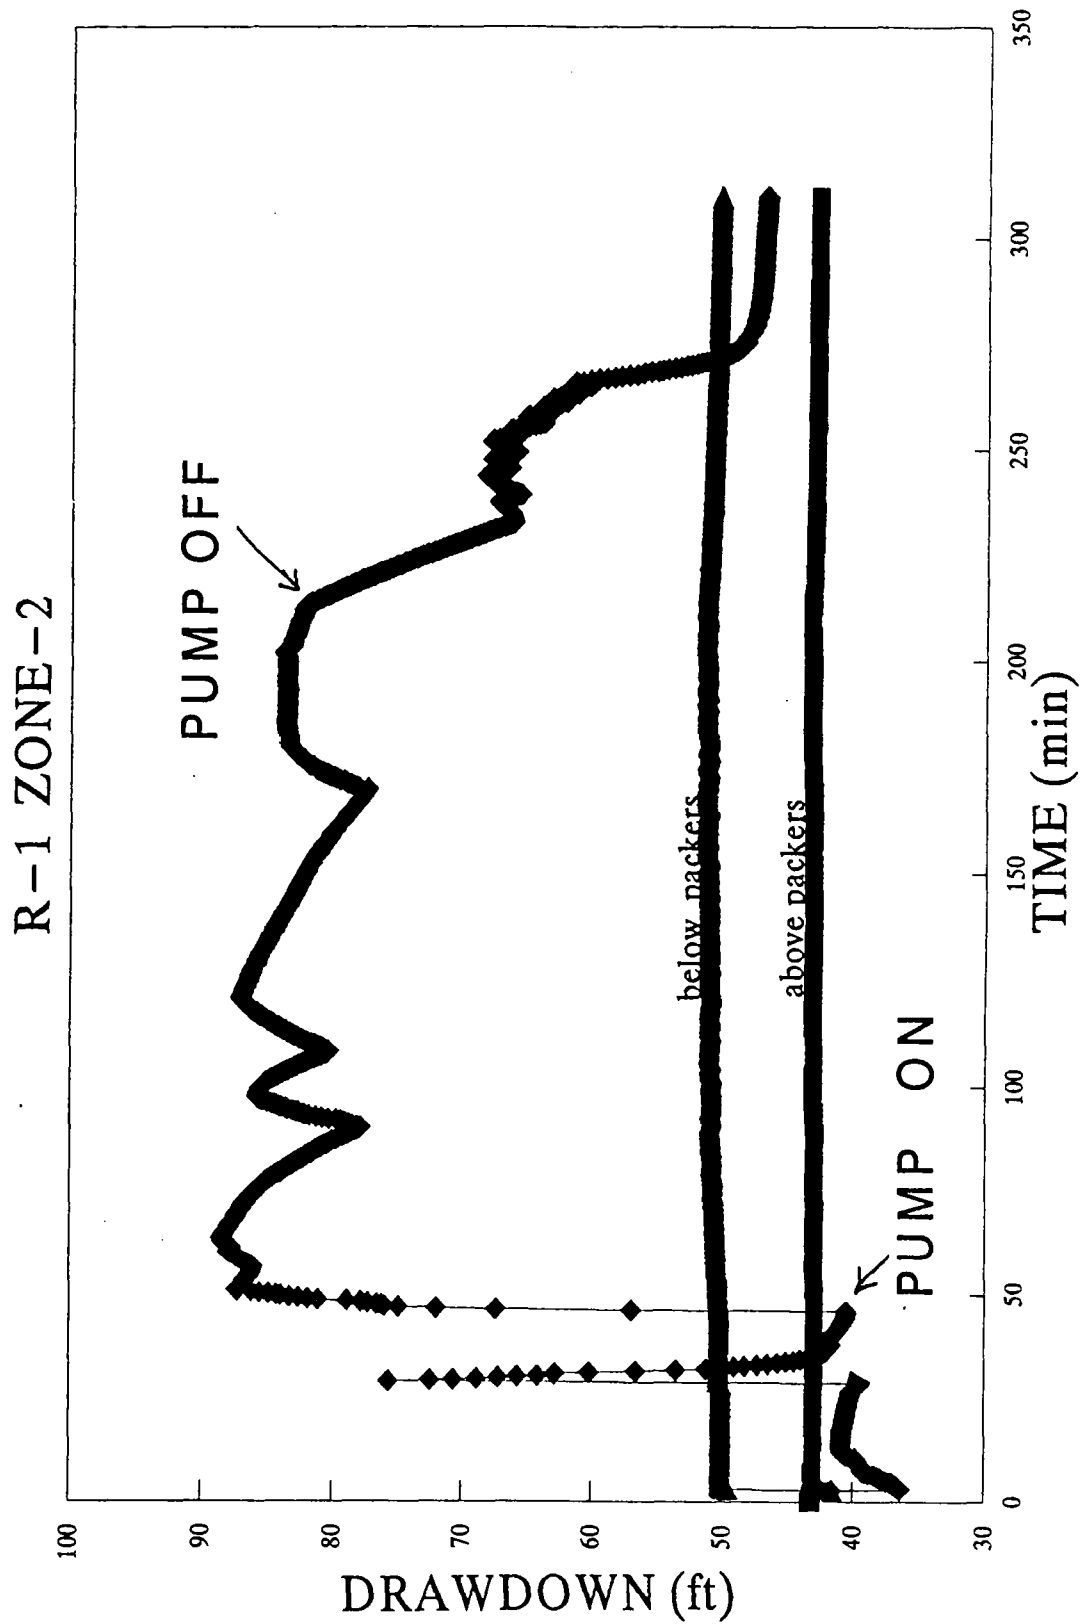
Figure 3-4: Water Level Drawdown Curves for the Pumping Well for Test R-1, Zone-2

The time-drawdown graph for Well R-1, test Zone 2 is shown in Figure 3-4. The flow rate was adjusted to a maximum rate of 0.3 gpm. Some minor fluctuations occurred in the pumping rate and the drawdown. The sudden drawdown indicated on Figure 3-4 at approximately 30 minutes was caused by a leaking check valve which was repaired and the test resumed at approximately 50 minutes. The water level between the packers was lowered 50 feet during the drawdown test then fully recovered when the pump was shut off. The water levels above the upper packer and below the lower packer did not change during the test. The time-drawdown graphs for the Zone 2 observation wells on Figure 3-5 show that none of the wells were affected by the pumping of Zone 2. Figure 3-6 shows the time drawdown graph for Well R-1 test Zone 3. The water level between the packers was lowered 14 feet during the drawdown test, then fully recovered when the pump was shut off. The water level above the upper packer did not change during the test, but the water level below the lower packer was lowered approximately one foot when the pump was turned on then quickly leveled off. This may have been due to an initial leak around the packer or minimal groundwater movement through the lower shale layer. The time-drawdown graphs for the Zone 3 observation wells on Figure 3-7 show that none of the wells were affected by the pumping of Zone 3.

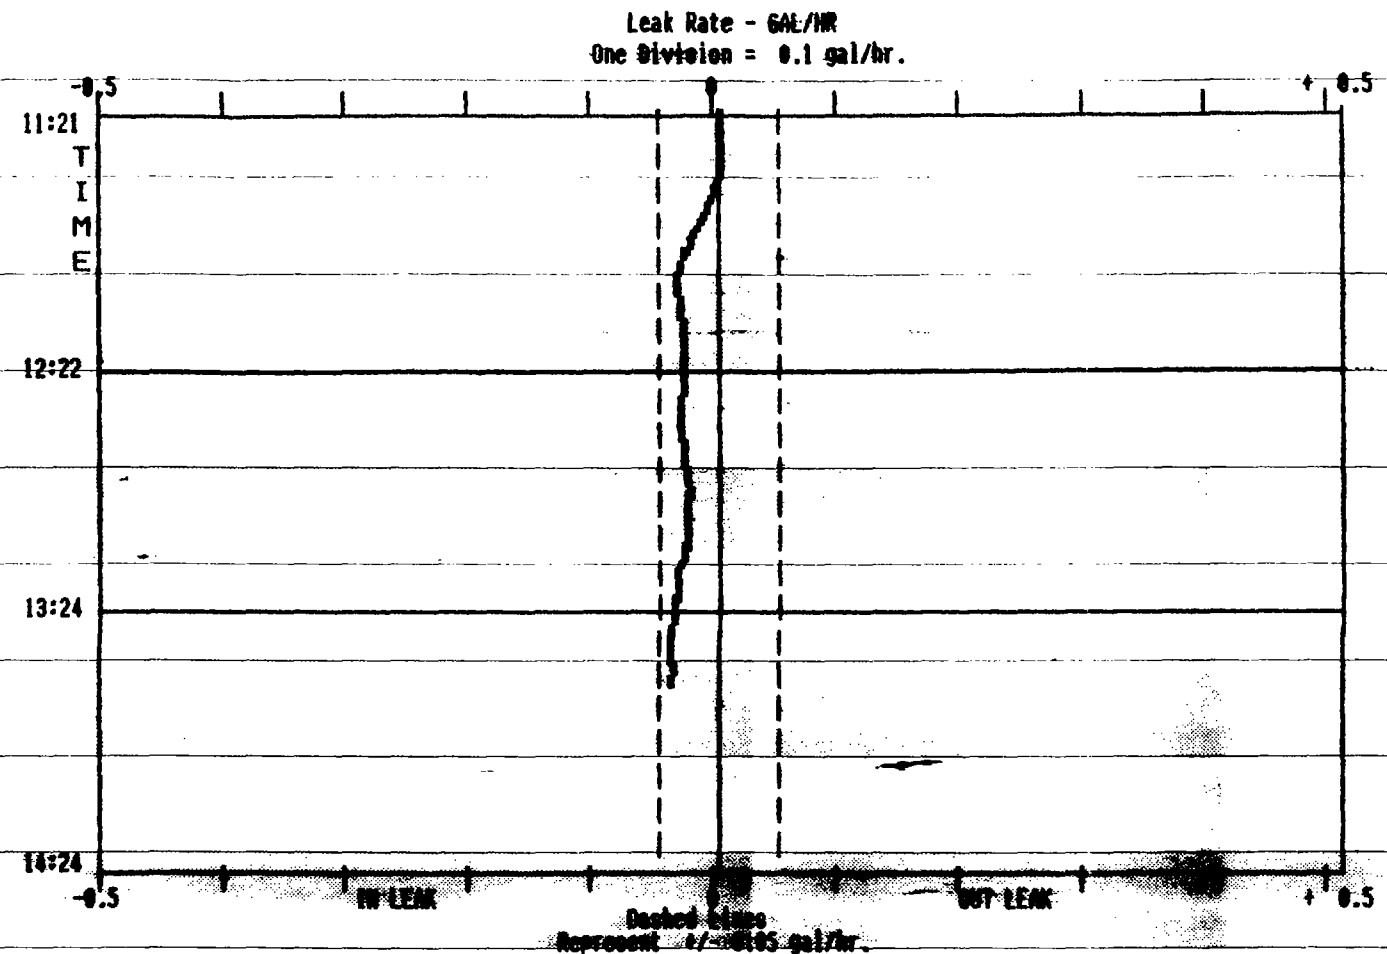
TEST RESULTS^(B)
Final Average Leak Rate: less than 0.05 gal/hr.
Rate of Temperature change: -0.0429 deg F/hr.
Rate of Volume change: -0.0042 gal/hr.
0.99 Error Band: +/- 0.01 gal/hr.
Tank and System: TIGHT @ 40 inches ABOVE Tank Top.

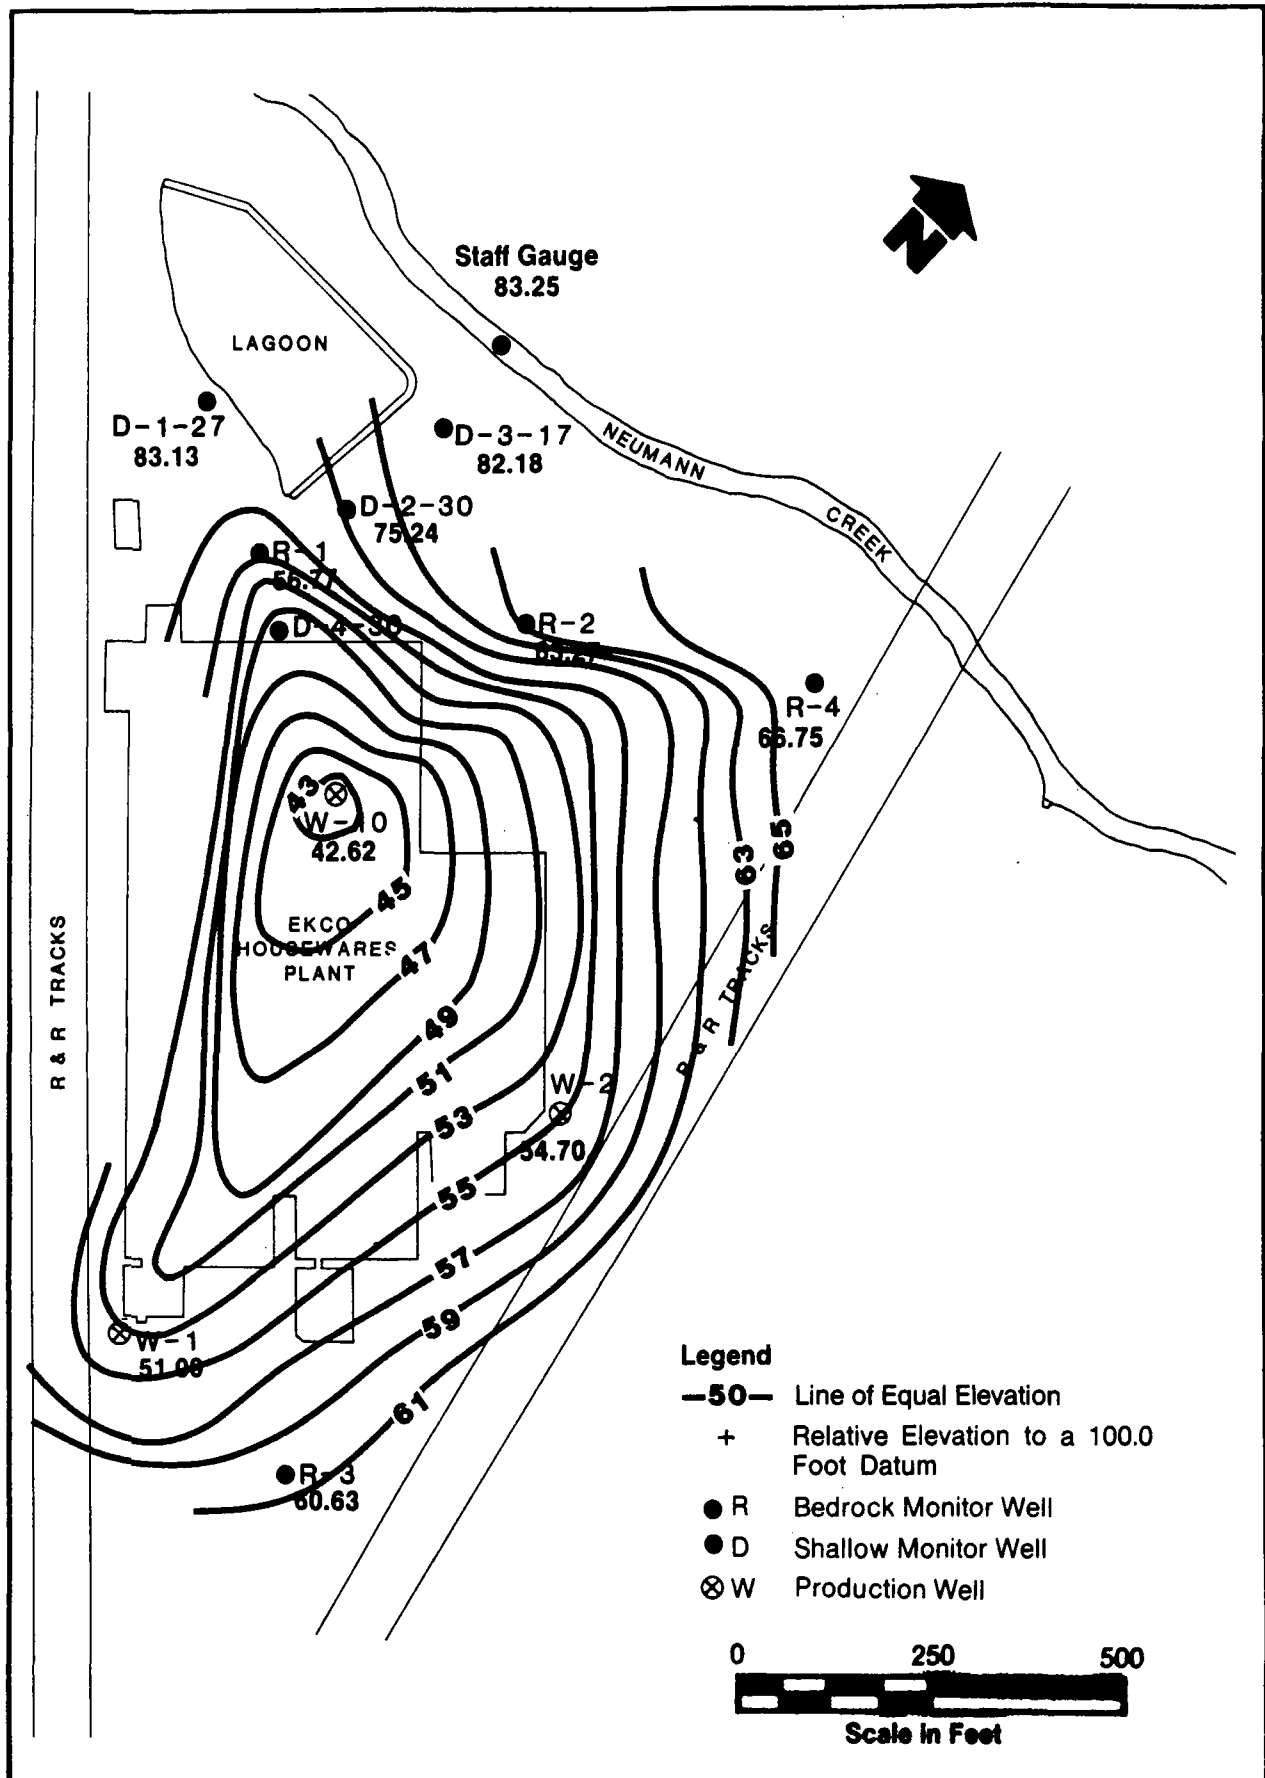
**FIGURE 4 CONTOUR OF BEDROCK GROUNDWATER ELEVATIONS +
EKCO HOUSEWARES, INC., MASSILLON, OHIO**

Figure 4 was generated using the ground water elevations for the wells installed in the Pottsville Sandstone. From this, it is difficult to determine the natural ground water flow direction because the major withdraws from W-1 and W-10 are causing a cone of depression and the ground water to flow radially toward the center of the site (to W-10).
